4.14.2 SWMU NO. 14.2 - STORMWATER AND SPILL COLLECTION SUMPS (Photographs 16-18)

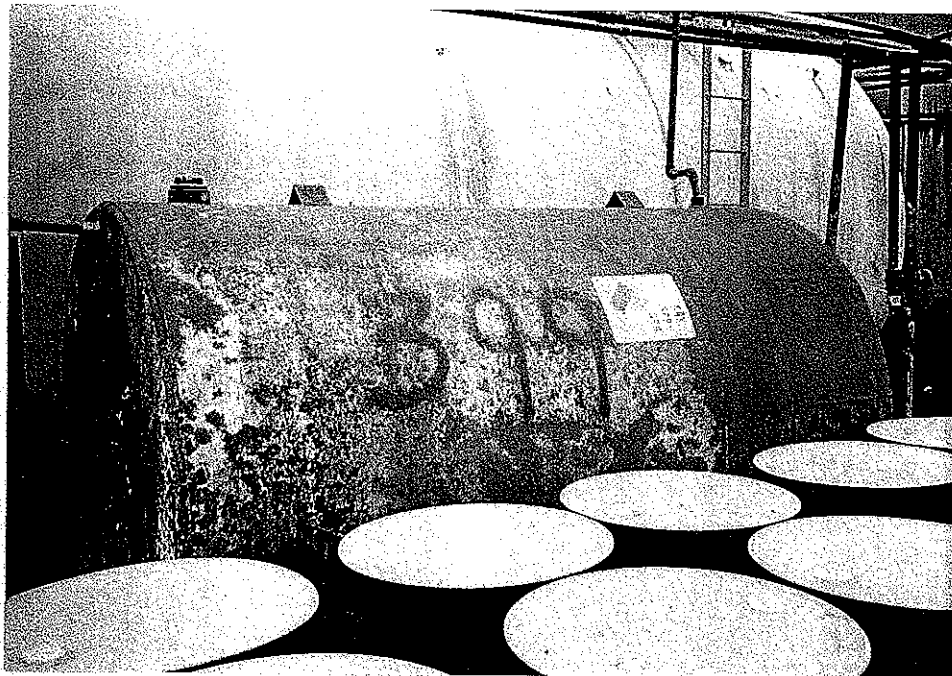
10. 01-30-92, 01:24 p.m. View to the north. Waste Oil Storage Tank (SWMU No. 13), KMCO's 500-gallon used oil storage tank. Photograph taken by David Michelsen.

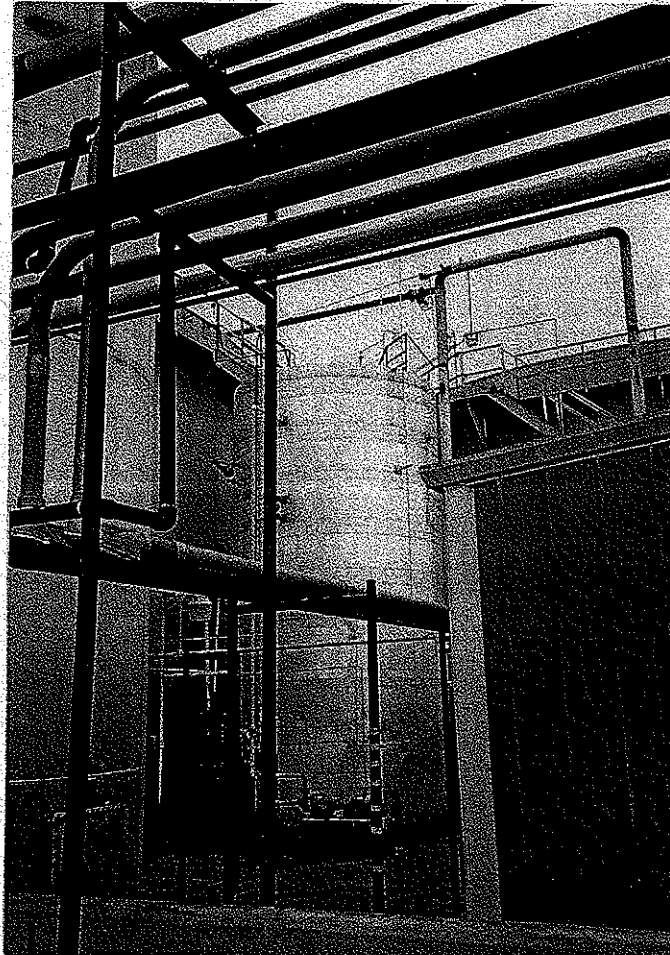
The Adjusting Tanks are two identical, above-ground steel tanks, constructed of two-inch steel. They are both open-topped and each hold 20,000 gallons. The Adjusting Tanks are not located on a pedestal but sit directly on the concrete slab that constitutes the surface of the Wastewater Treatment Plant. The Adjusting Tanks are located near the midpoint of the northern dike of the Wastewater Treatment Plant. The tanks both have high level alarms to prevent overflow. In addition, the Adjusting Tanks are surrounded by berms as discussed in Section 4.16. Both are on good condition with some surface rust but no signs of waste releases.

The Adjusting Tanks are well maintained and constructed of two-inch steel walls to withstand any corrosive effects of the wastewater. Some minor surface rust is visible. Three forms of secondary containment, a high level alarm, daily measurement of the tank level, and a berm around the Wastewater Treatment Plant prevent environmental releases. In addition, no signs of waste releases were observed during the January 30, 1992 VSI.

22. 01-30-92, 12:00 p.m. View to the southeast. Adjusting Tanks (SWMU No. 15.1) for KMCO's Wastewater Treatment Plant. Photograph taken by David Michelsen.

ICF recommends no further investigation of this SWMU.

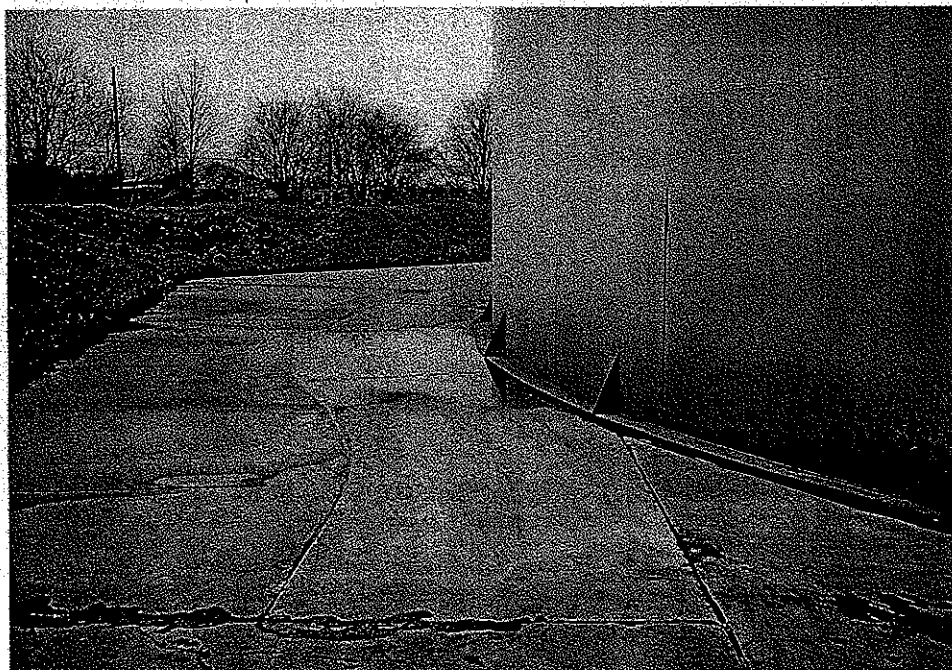
The Equalization Tank is well maintained and constructed of two-inch steel walls to withstand any corrosive effects of the wastewater. Secondary containment, provided by a high level alarm and a berm around the Wastewater Treatment Plant, prevents environmental releases. The tank was in very good condition and there were no other signs of waste releases observed during the January 30, 1992 VSI.

24. 01-30-92, 11:53 a.m. View to the southwest. Equalization Tank (SWMU No. 15.3) for KMCO's Wastewater Treatment Plant. Photograph taken by David Michelsen.

25. 01-30-92, 11:54 a.m. View to the southeast. Equalization Tank (SWMU No. 15.3), concrete pad, and earthen berm. Photograph taken by David Michelsen.

ICF recommends no further investigation of this SWMU.
